## Valuation

V-06121

Crane type:	Demag CC 2600
Serial No.:	64109
Year of manufacture:	1996
Max. lifting capacity:	500 t with Superlift, 550 t with Superlift and add. equipment
Operating hours:	18 556

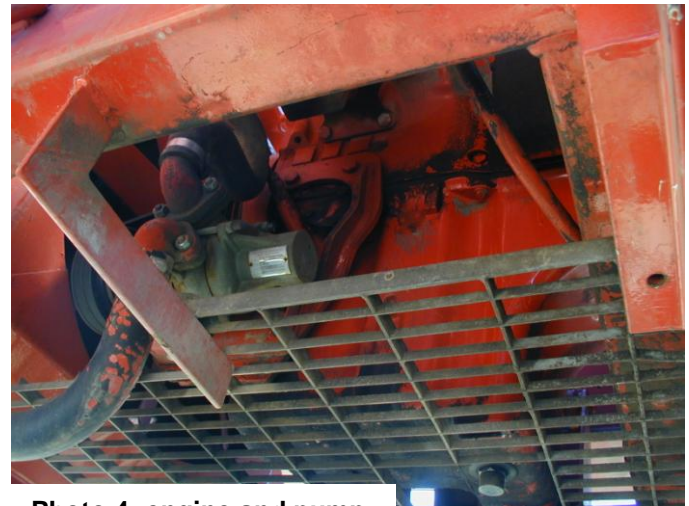
**Photo 4: engine and pump**

At engine and mounted pumps are no leakage found. The engine is a little bit dirty, but it looks good for this age.

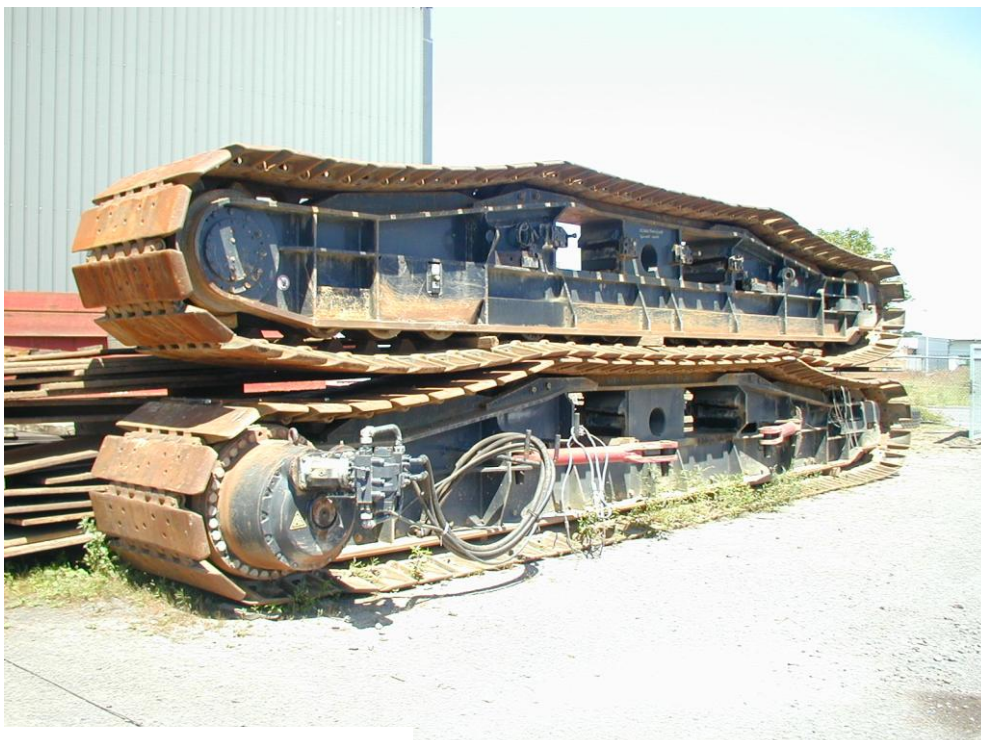
Photo 7: crawler carriages

There are no cracks or failings at steel constructions, welding seams or the chains found. The profiles of the gearings and the chain wheels look even the high hours of the crane good, some areas are a little bit rusted. The engines and the gear boxes are dry.

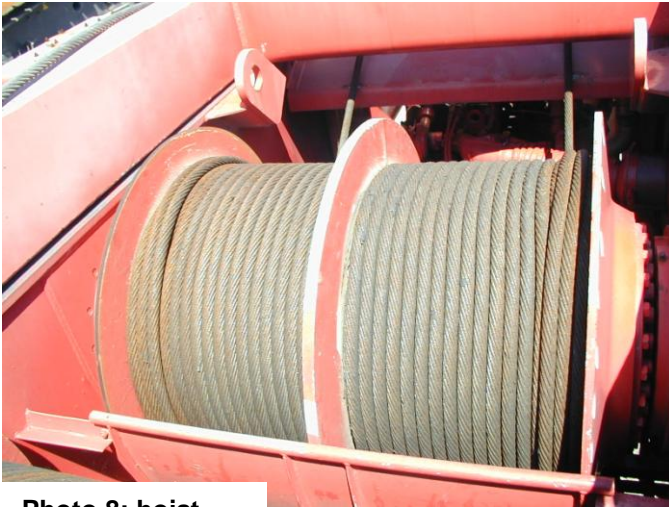
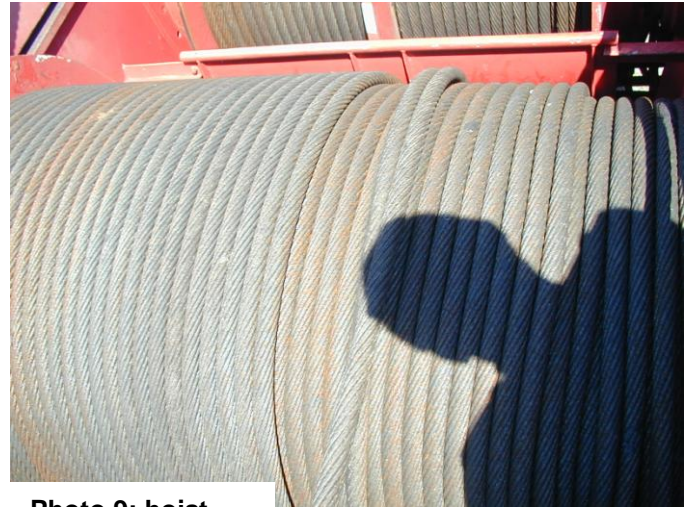
At the engine of the hoists are no leakage found. The ropes of hoist 3 and hoist 4 are rusted. It looks like the rust is only at the surface of the ropes.

But the rust must be removed and the ropes must be greased. Additional the ropes of hoist 1 and hoist 2 must be greased.

changing sealing of engine of slew gearbox	2.000.-€
ropes of hoists derusting and greasing	5.000.-€
changing of the rolls of luffing head	2.000.-€

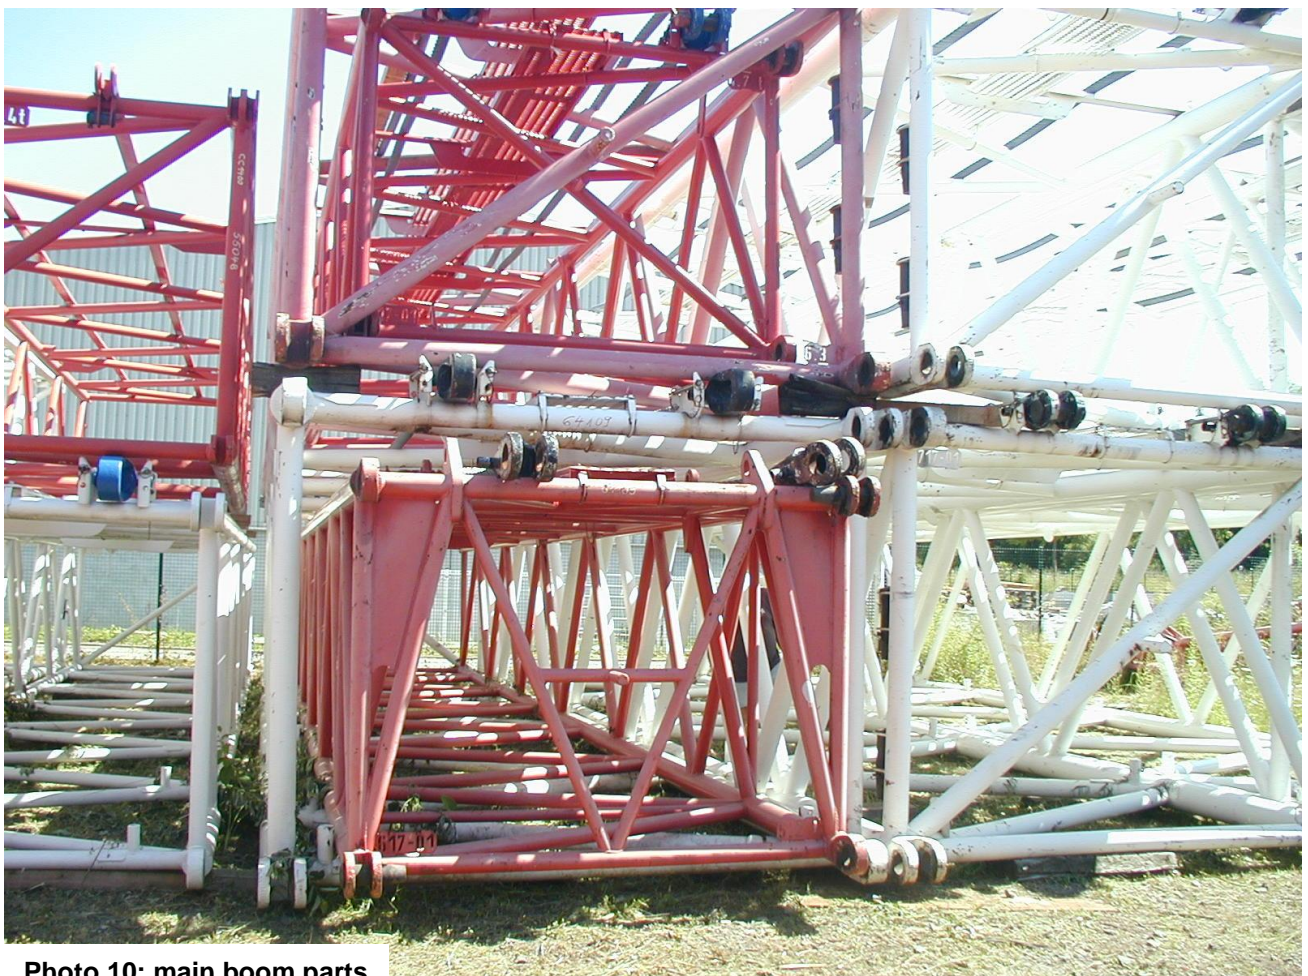
Photo 10: main boom parts

The parts of main boom, luffing jib, superlift and the luffing mast are in good conditions. There are no dents, deformation or cracks found.

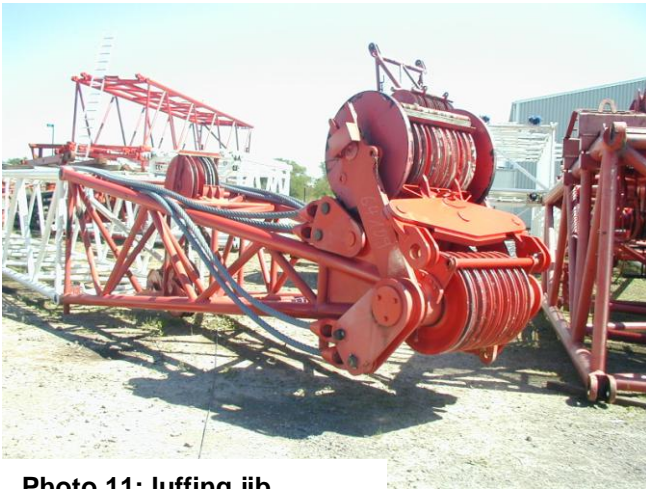
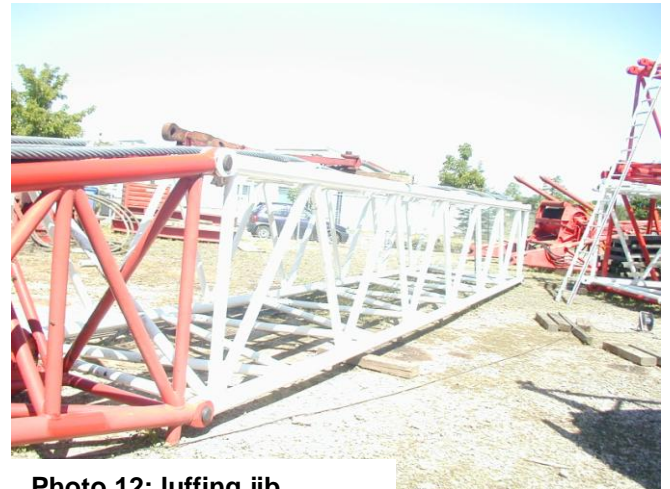
The rope rolls and other mounted parts are in good conditions, only at the head of the luffing jib are 2 rolls damaged.

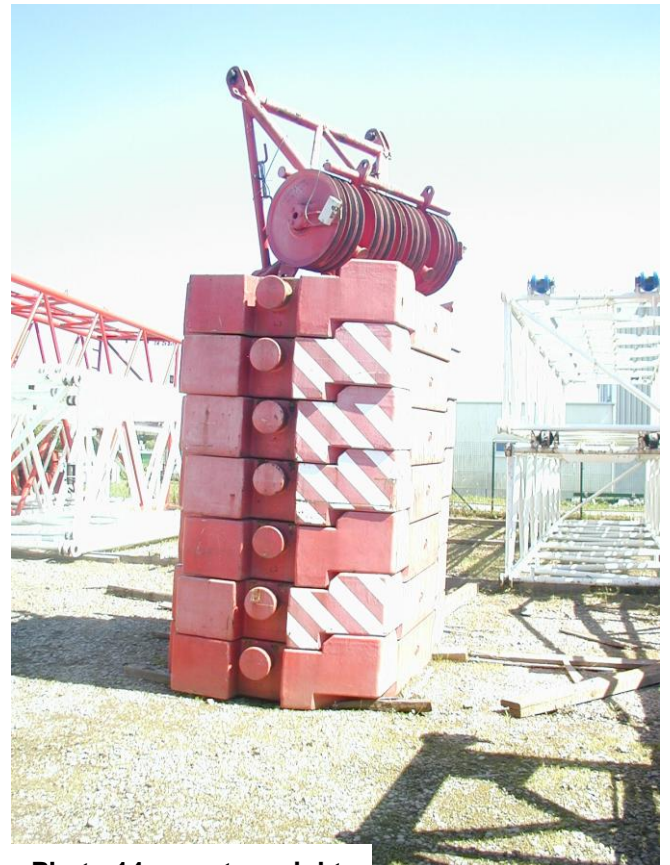
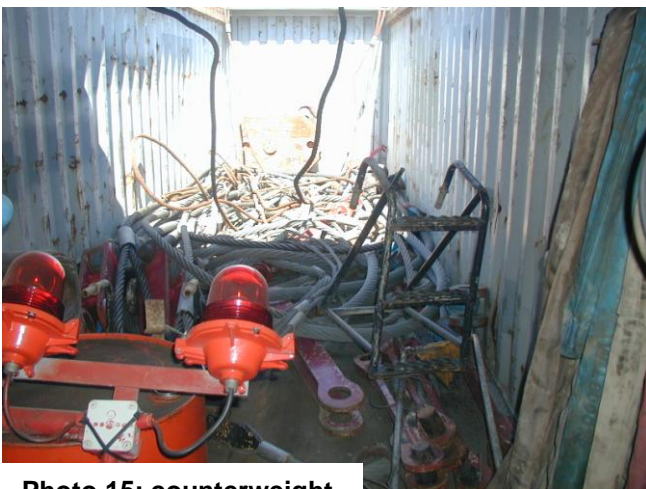
Counterweights, base plate for counterweight and the frame for the SL-counterweight are in good conditions.
